# CAUSES OF LANDSLIDES AND ITS CONSEQUENCES

Dr. A.K. Naithani

Sr. Scientist & HoD, Engineering Geology Department  
National Institute of Rock Mechanics (NIRM), Bengaluru

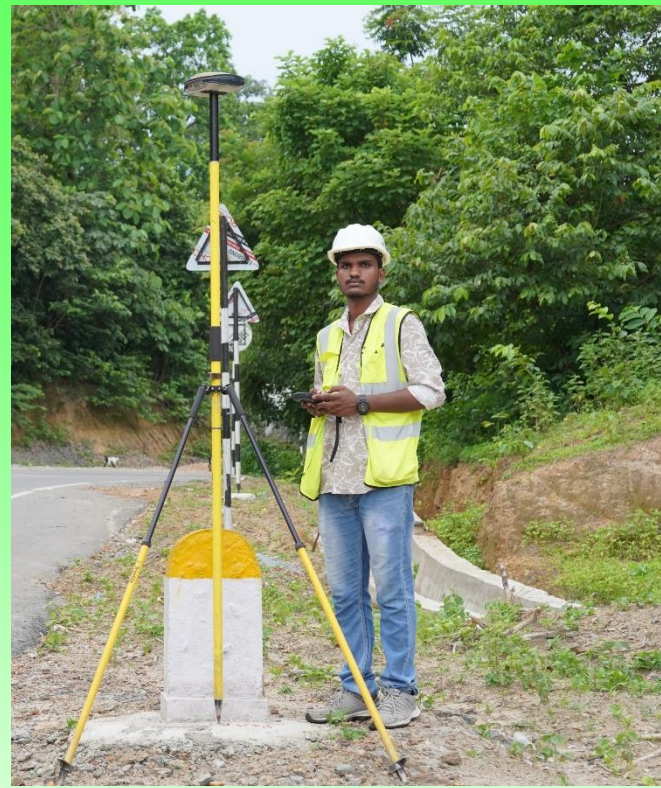
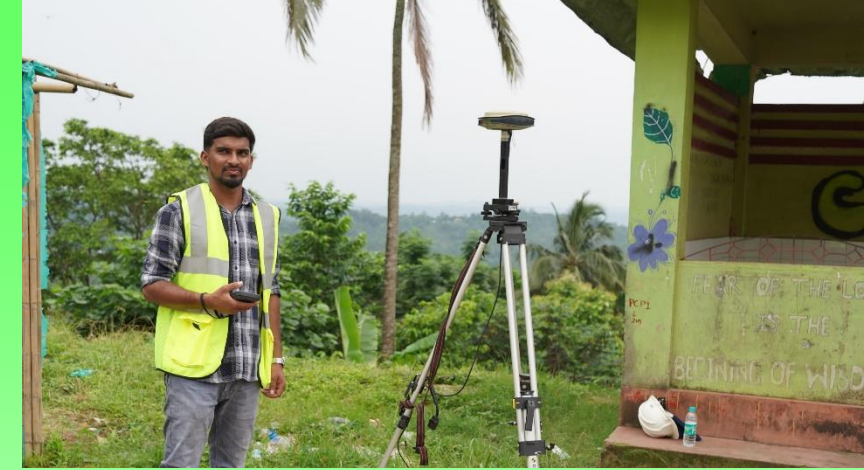
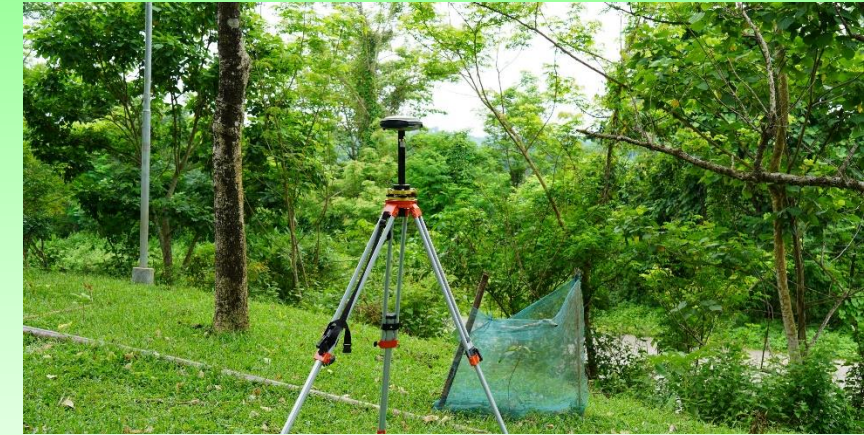
DGPS (Differential Global Positioning Systems) is used for Control Points Logging. Multifrequency GNSS (Global Navigational Satellite Systems) Receivers were used for logging readings at certain fixed locations. These locations are called Ground Control Points (GCPs).

These points were used as control points to rectify the LiDAR scanning data. In this study SP80, a new generation GNSS receivers were used to log the ground control points.

As a first step, the permanent DGPS Control points set up by the client were identified on the site and same were used as control points to commence the survey.

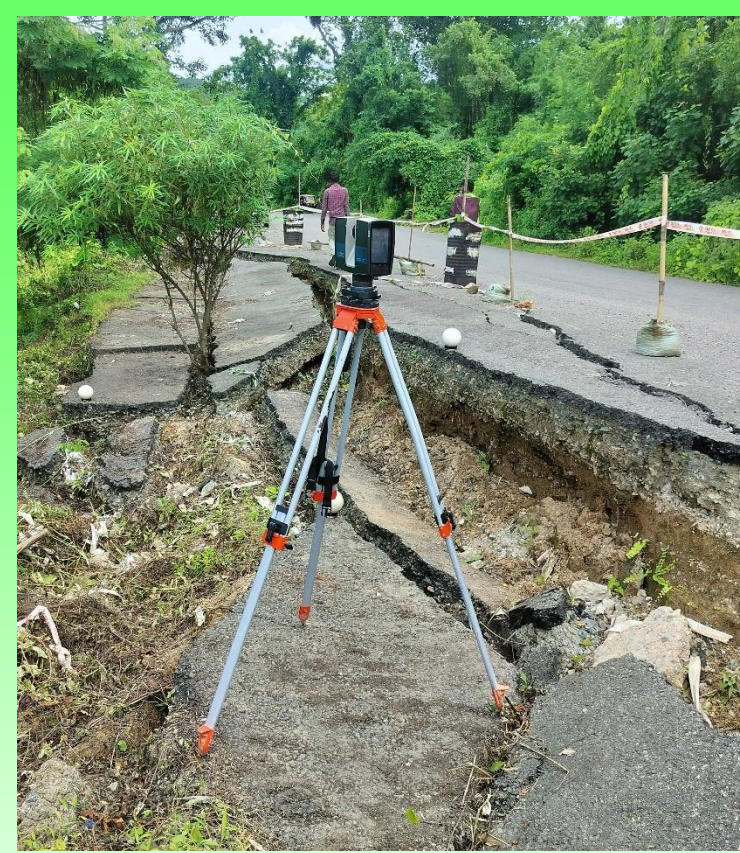
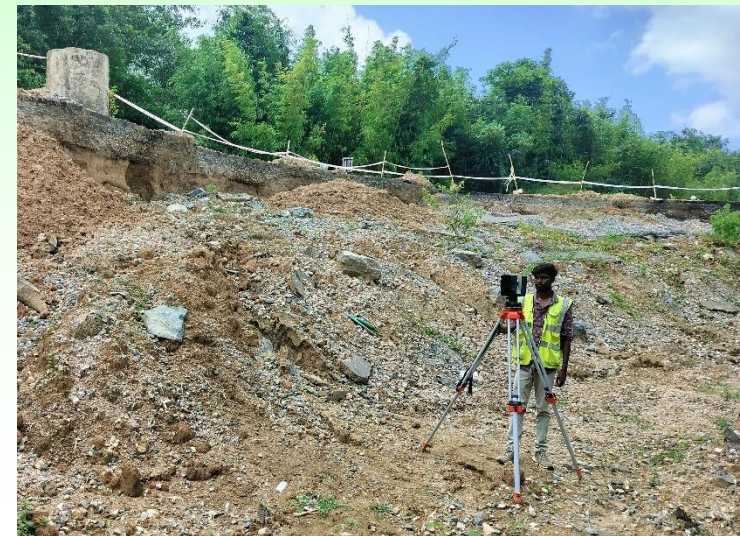
- The next step was to map the project area using LiDAR Scanner for recording the levels of the ground and to map all the physical features relevant to the project.

- The scanning was done using Faro Focus S350 scanner. The scanner was placed at several locations at the affected portions.
- The scanned data was downloaded into Scene – software for LiDAR data processing. The individual scans were registered using control points that were logged using the DGPS.

- The registered scans were used to generate point clouds of the surveyed features.
- The point cloud was then filtered to achieve a bare earth terrain data.

- The filtered data was then **used to extract contours of 1 m interval.**
- The scanned data was also used for **delineating other physical features** viz., roads, buildings, bridges, culverts, drains, etc.

- The processed topographic data was then used **for generating cross sections** across the affected sections of highway.

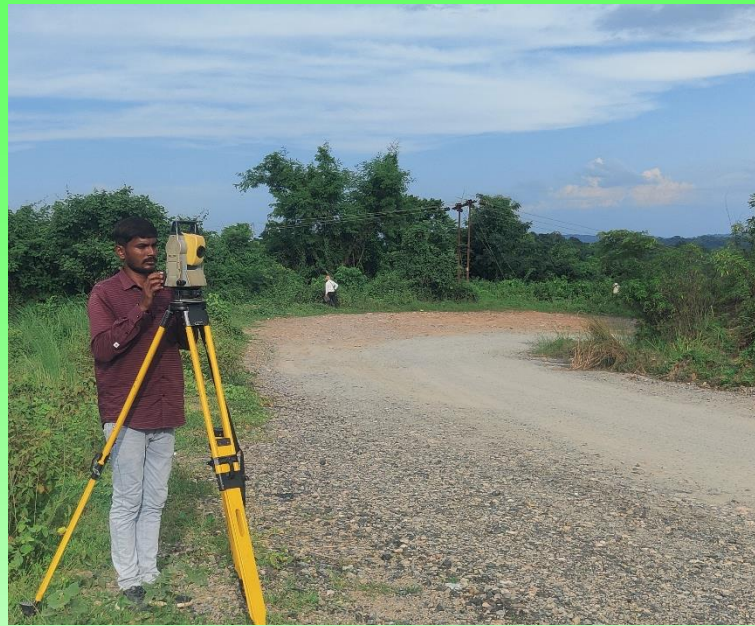
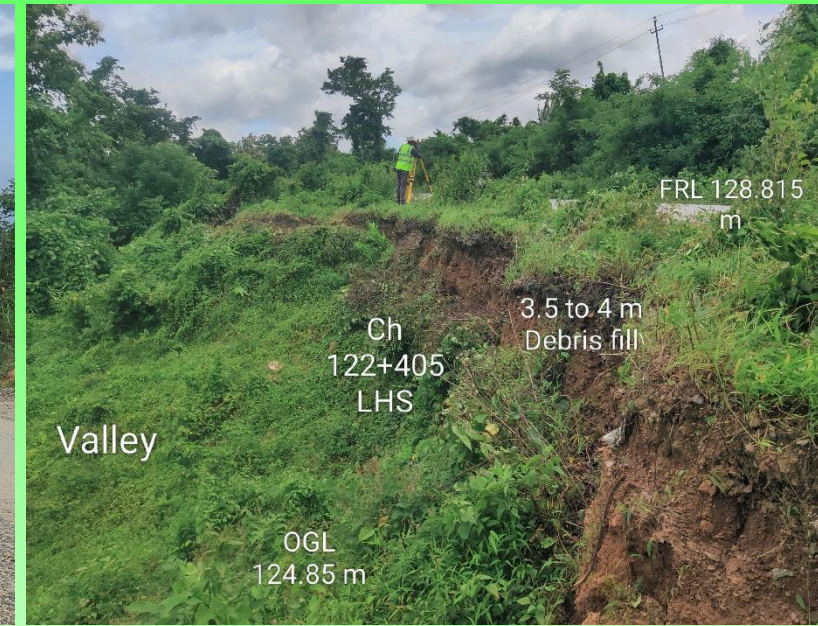
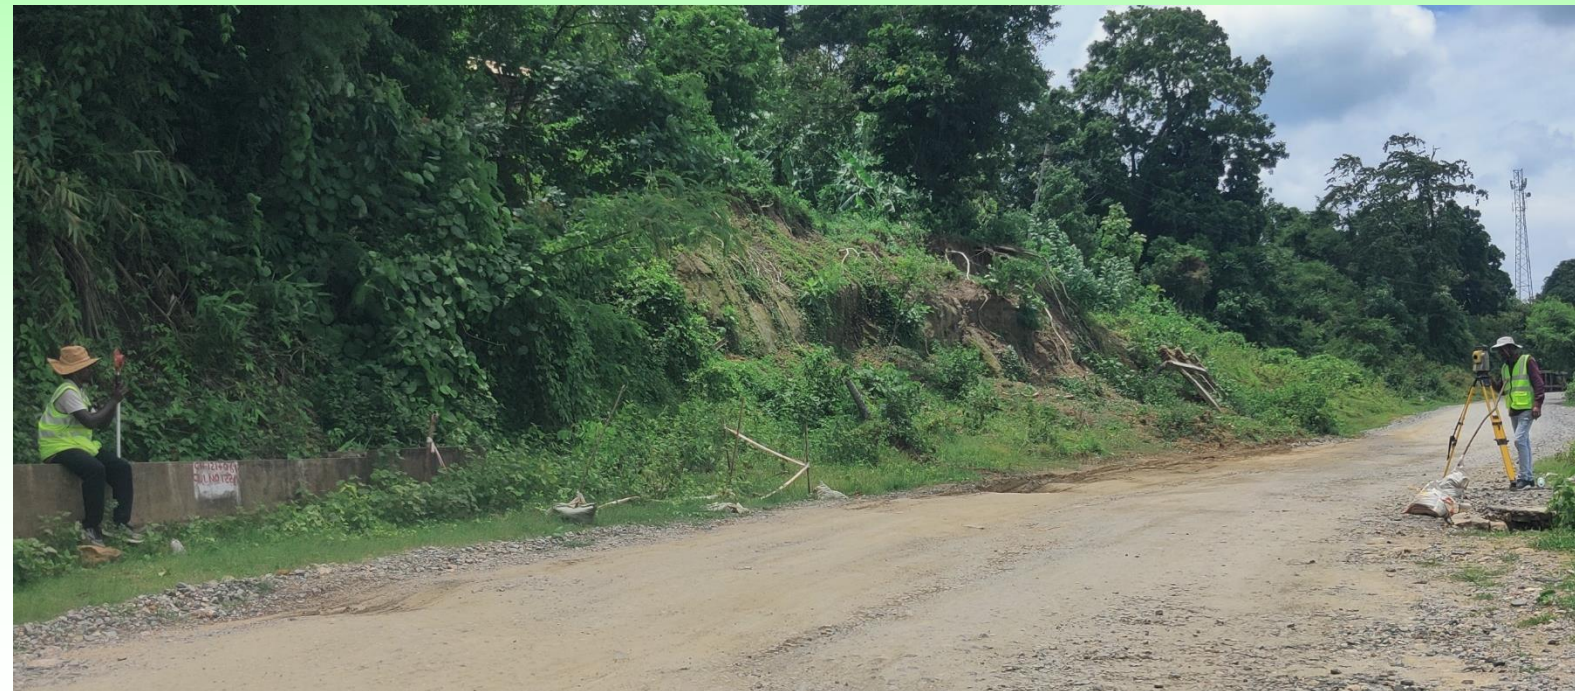
**SZ-08 (3) (Ch. 115+730 to 115+780 km)**

- Total Station survey equipment was used for recording positions and dimensions of cracks.
- The extents of the cracks recorded by Total Stations were helpful for filling up data formats devised by the geologist.
- The field observations being carried out required in situ results related to cracks, subsidence extent and displacement of structures from their original positions.
- The field assistant would place the target prism on the feature to be mapped viz., road edge, crack, culvert etc., and the operator would record that position using the Total Station.
- The chainages marked on permanent features by the client were used as reference for the chainages.

16.	Road drainage	Temporary drain on LHS
17.	Specific characteristics of the site	Cracks observed in the on LHS, RHS and middle part of the road Crack length: >20 m, Width: 20 cm Vertical displacement: 30 cm

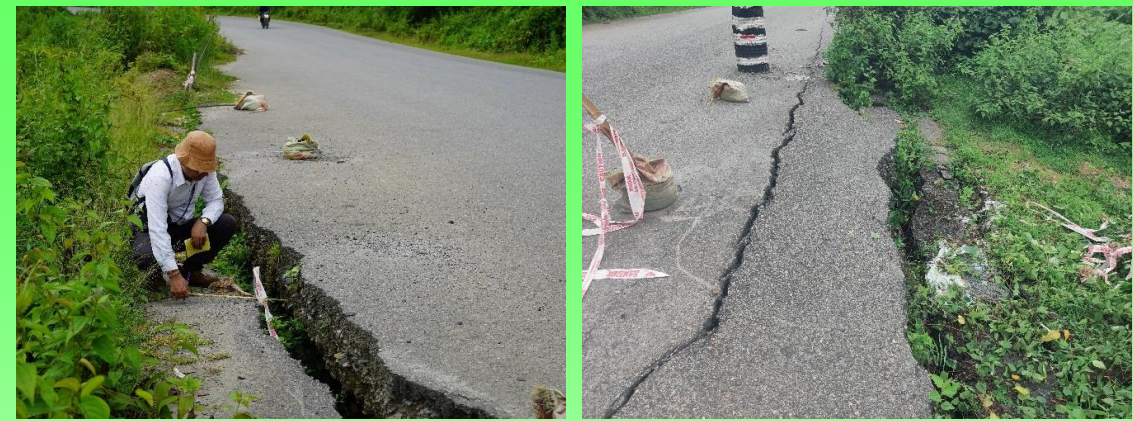
Fig. 21: Longitudinal open cracks (up to 25 cm wide) with vertical displacement (up to 30 cm) mapped along right edge of the pavement near Ch 115+867 km

Due to the nature of foundation soil, embankment settlement/subsidence is going on. The following factors may contribute to the development of these cracks:

- Lack of literal support from the shoulders.
- Inadequate surface drainage, especially during flooding conditions.
- Shrinkage due to drying out of the surrounding earth, generally caused by roots of trees or bushes close to the pavement edge. Highly expansive soil is particularly prone to shrinkage when moisture dries out.
- Settlement or yielding of the underlying material.
- Inadequate pavement thickness, inadequate pavement width forcing traffic to be too close to the edge of the pavement and non-provision of extra width of pavement on curves.

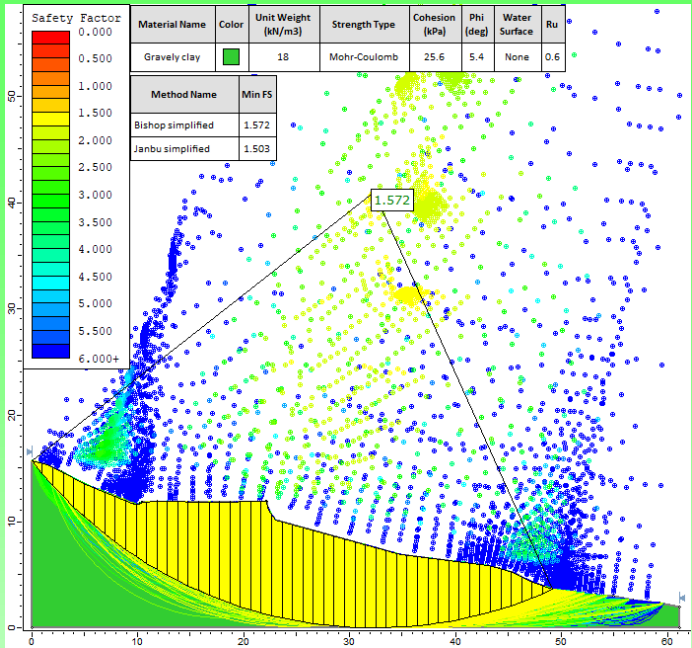
Factor of safety contours for slide area at B-B'-section line (Cluster-5) at Ch. 124+840 km

- The slope stability and landslide analysis are carried out using Slide2 software.
- Slide2 is a 2D slope stability analysis developed by RocScience Inc., widely used in the field of geotechnical engineering.

- For sinking zones/landslides stability analysis has been carried out using the Limit Equilibrium Method (LIM) which is the most common approach for analysing slope stability.

- To develop a model for slope stability, it is essential to define the problems geometry and boundary conditions.
- The input parameters required to analyses slope stability are unit weight, cohesion, angle of internal friction, and pore water pressure ratio (Ru) for static case, however, in the dynamic case, one additional parameter namely, coefficient of horizontal seismic acceleration is required along with other input parameters of static case.

- Detailed limit equilibrium analysis was conducted to assess the stability of landslide-prone areas and zones affected by ground subsidence or sinking.

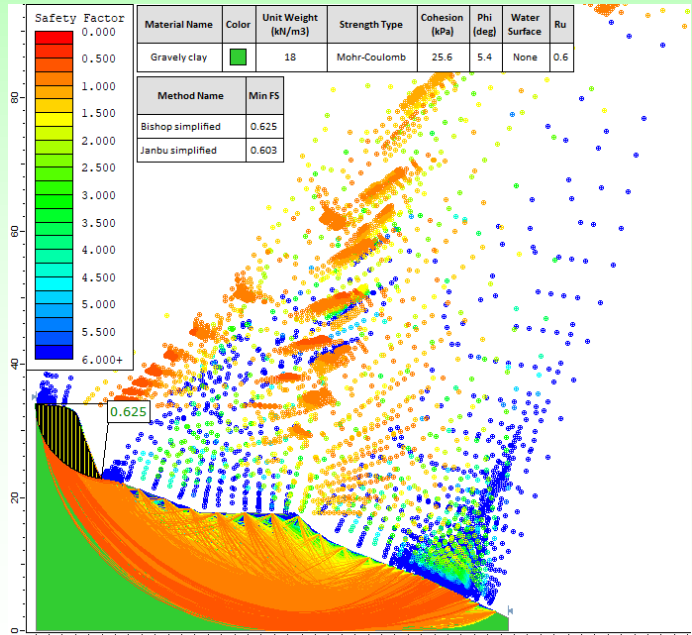
Factor of safety contours for slide area at A-A'-section line (Cluster-5) at Ch. 125+227 km

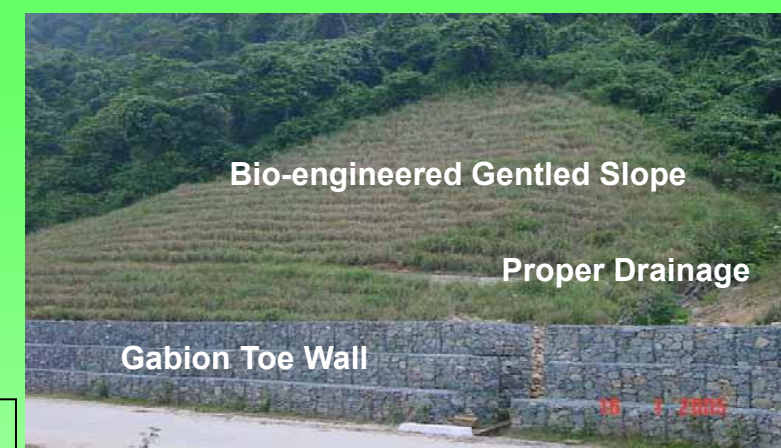
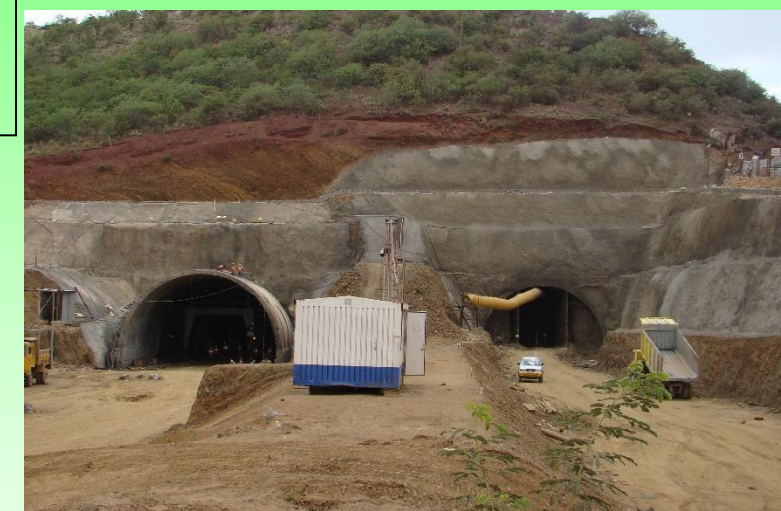
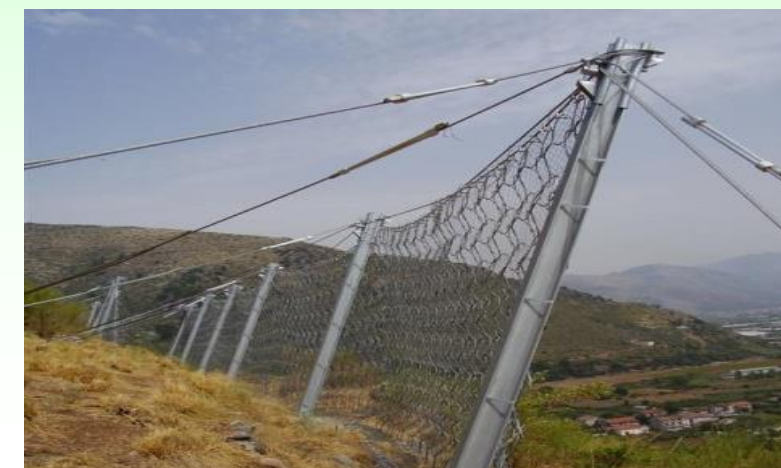
Reticulated Micro Piles

Reinforced Slopes

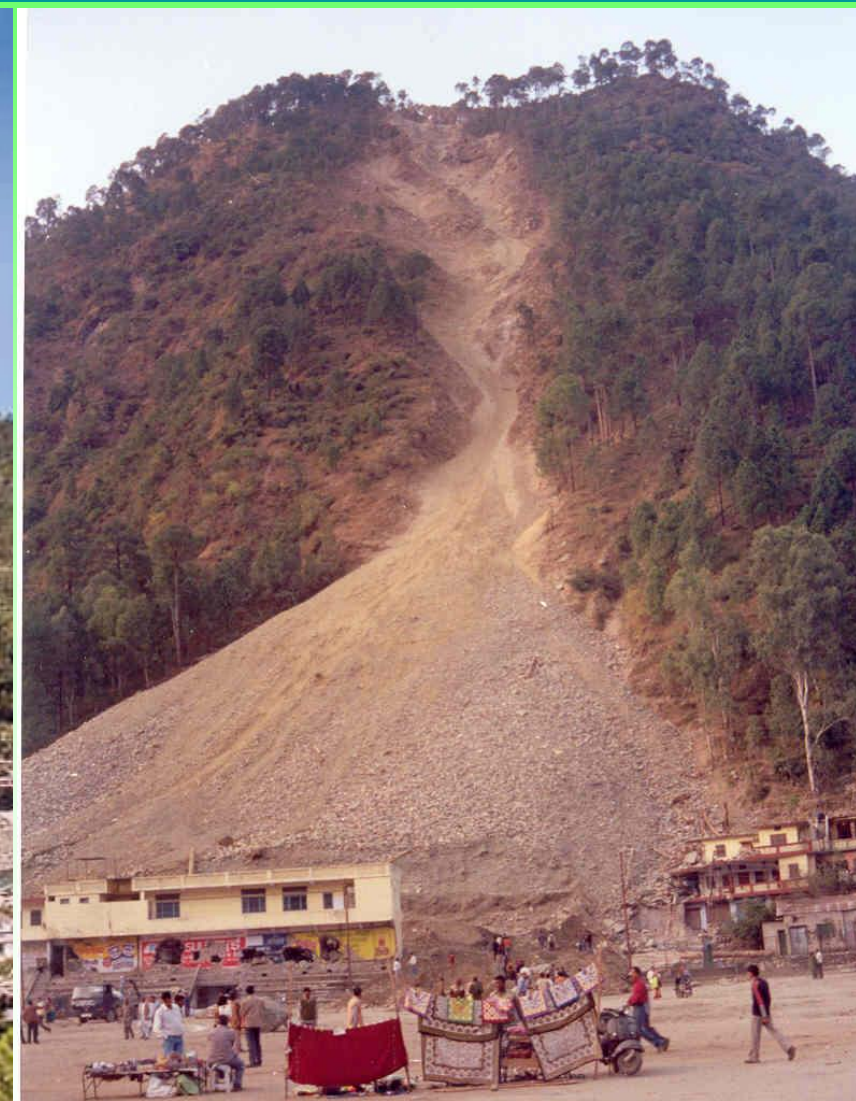
Thick debris in Higher Himalayan valleys provide space for agricultural fields & hence settlements are mostly clustered around these valleys
